METALS HANDBOOK

VOL. 9
FRACTOGRAPHY AND ATLAS OF FRACTOGRAPHY

8th EDITION

Fractography and Atlas of Fractographs

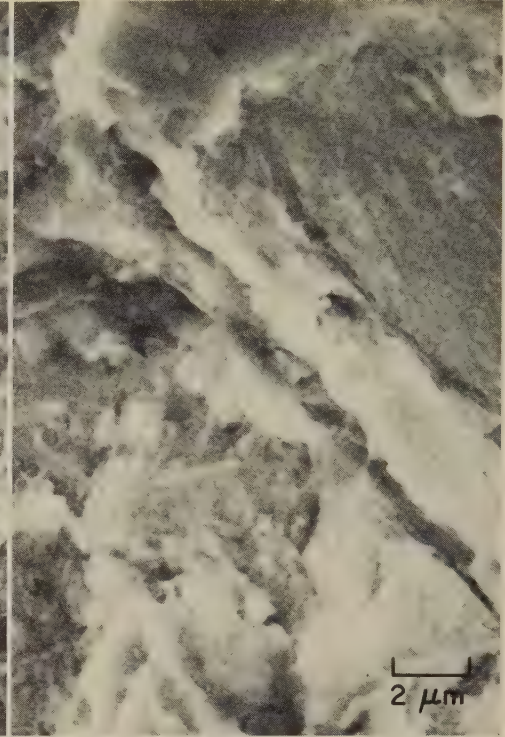
SEM fractograph 5000×
3720 Higher-magnification view of the area within the rectangle in fractograph 3719. The fracture surface appears to be obscured by corrosion products, which may be concealing evidence of dimples or of cleavage facets. See also fractographs 3721 to 3723, below.

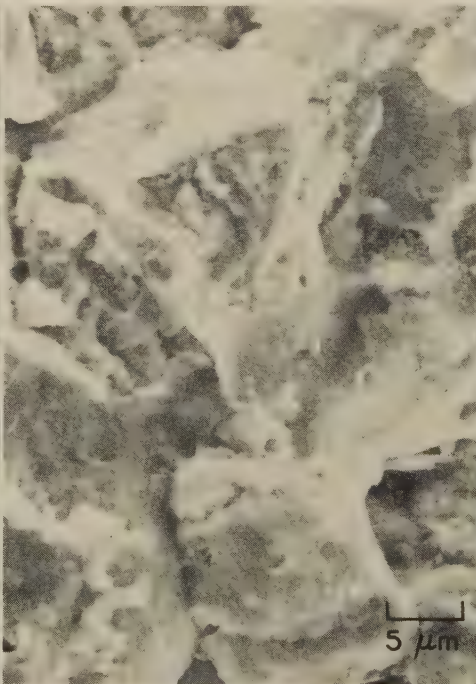
SEM fractograph 2000×
3722 Interior region about as far from edge in 3719 as 3721 is. A considerable amount of corrosion products is present, and the fracture seems to be completely intergranular with slight secondary cracks. See also 3723.

SEM fractograph 2000×
3723 A view of a region adjacent to that shown in fractograph 3722 (left), revealing distinct grain-boundary secondary cracks. Hairline indications are visible on several of the grain facets. A slight amount of debris is present as well.

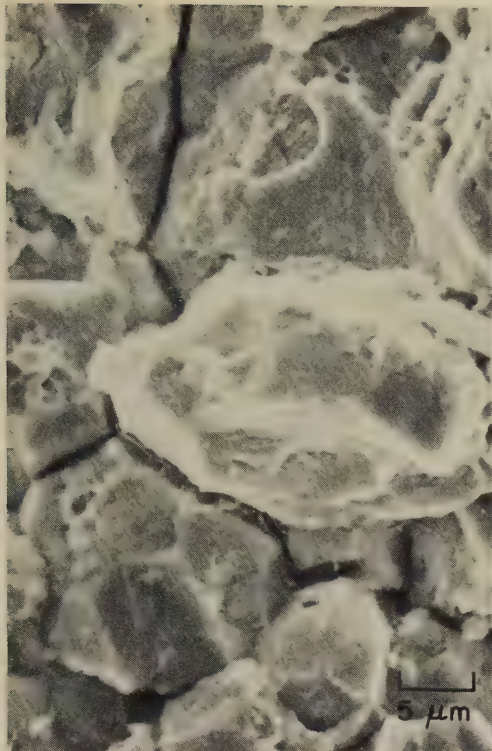
SEM fractograph 2000×
3724 Same fracture surface as in 3718 to 3723, showing a region farther from the outer edge than those in 3721 to 3723. Fracture path is completely intergranular, and pronounced grain-boundary secondary cracks are evident.

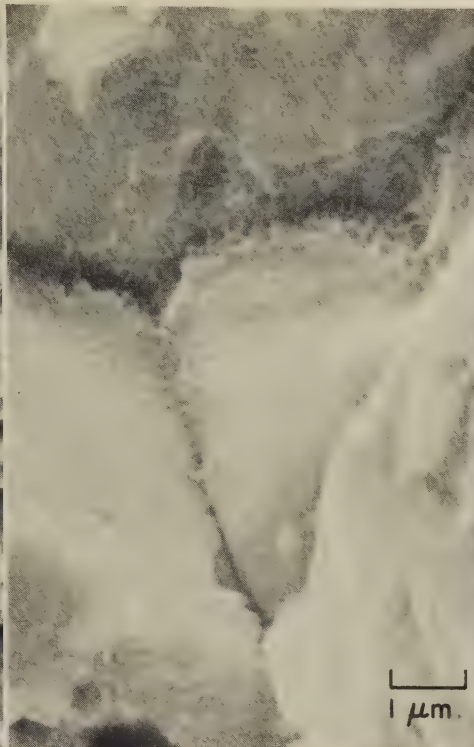
SEM fractograph 10,000×
3725 Same fracture surface as in 3718 to 3724, but a region farther from the outer edge than that in 3724 and shown at higher magnification. Intergranular path of fracture; fine dimples at grain boundaries and on several facets.

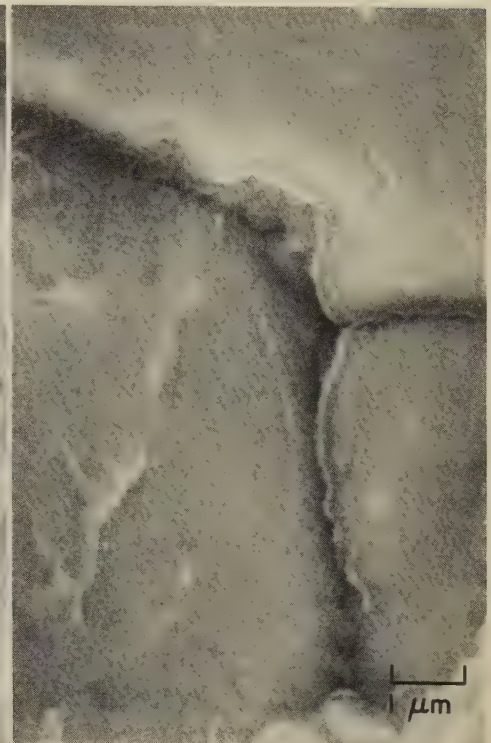
SEM fractograph 10,000×
3726 Another region of the fracture surface in 3718 to 3725, similar to that shown in 3725 (left), but still farther from the outer edge of the crack. This region shows grain-boundary secondary cracks that contain fine dimples.

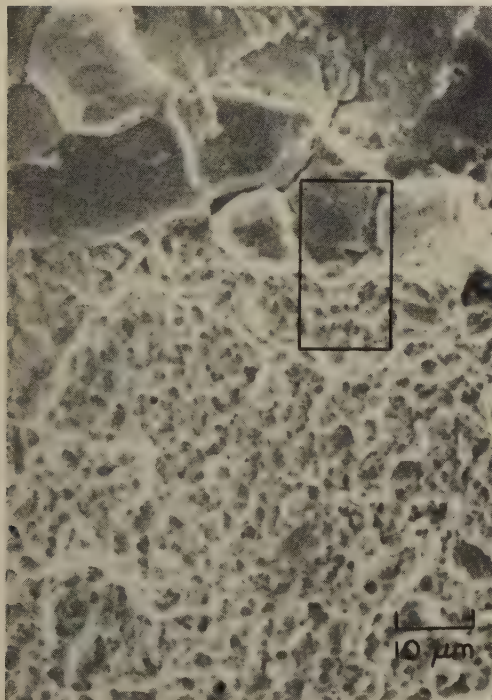
SEM fractograph 1000×
3727 A region at edge of fast-fracture (bright) zone of fracture surface in 3718, showing junction of this zone (bottom) with one that underwent stress-corrosion cracking. See 3728, a higher-magnification view of the area within the rectangle.

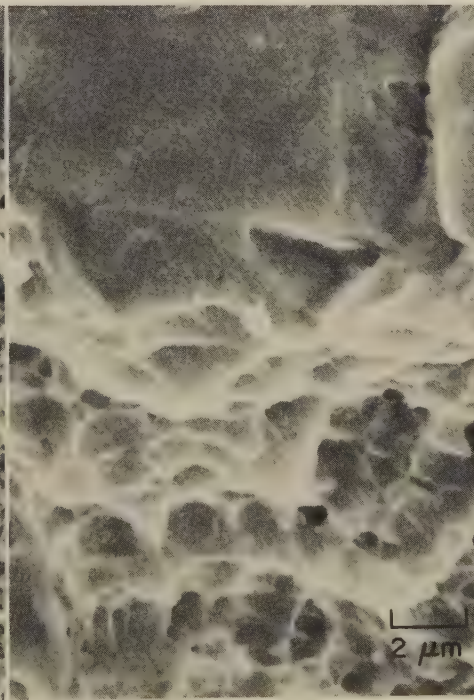
SEM fractograph 5000×
3728 Higher-magnification view of the area defined by the rectangle in fractograph 3727 (left), showing even more clearly than 3727 the abrupt termination of stress corrosion and the complete change to dimpled rupture (bottom).

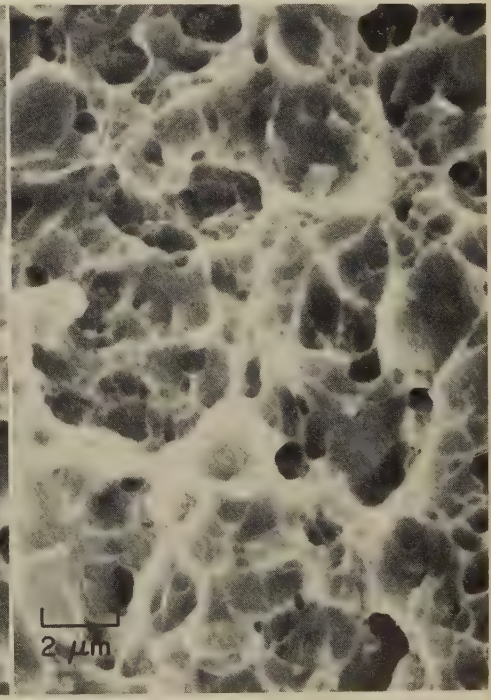
SEM fractograph 5000×
3729 Fracture surface of a thread adjacent to the one in 3718. This thread was cut, notched and broken in the same manner, but no prior crack was discovered and the dimpled rupture visible here covers the entire fracture surface.

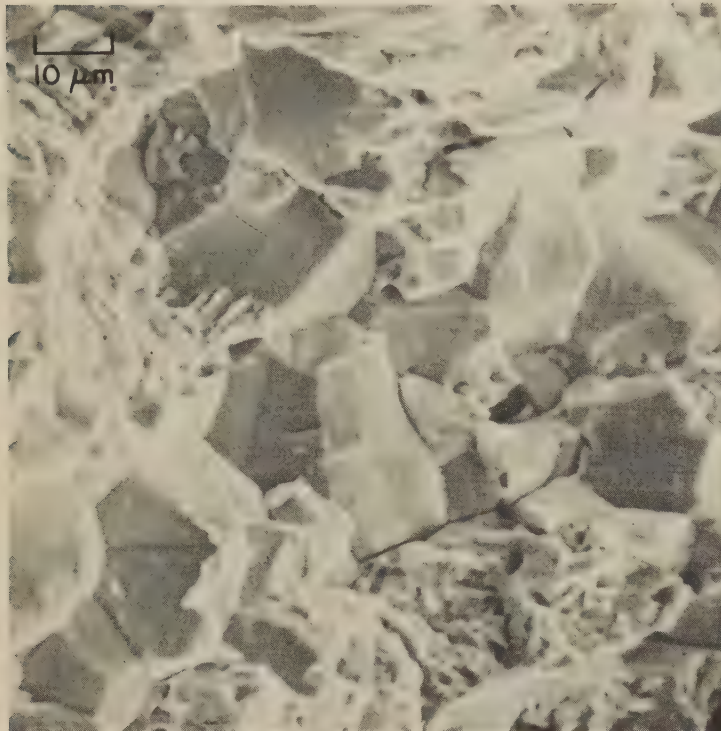
SEM fractograph 1000×
3730 Surface of a fracture in a specimen of 5155 steel that had been heat treated at 850°C (1562°F) for $\frac{1}{2}$ hr, oil quenched, and tempered at 350°C (662°F) for 1 hr. Hardness is 520 dph. The fracture was produced by impact at -196°C (-321°F). The fracture surface is rated as 95% brittle and 5% ductile. See also fractographs 3731 and 3732.

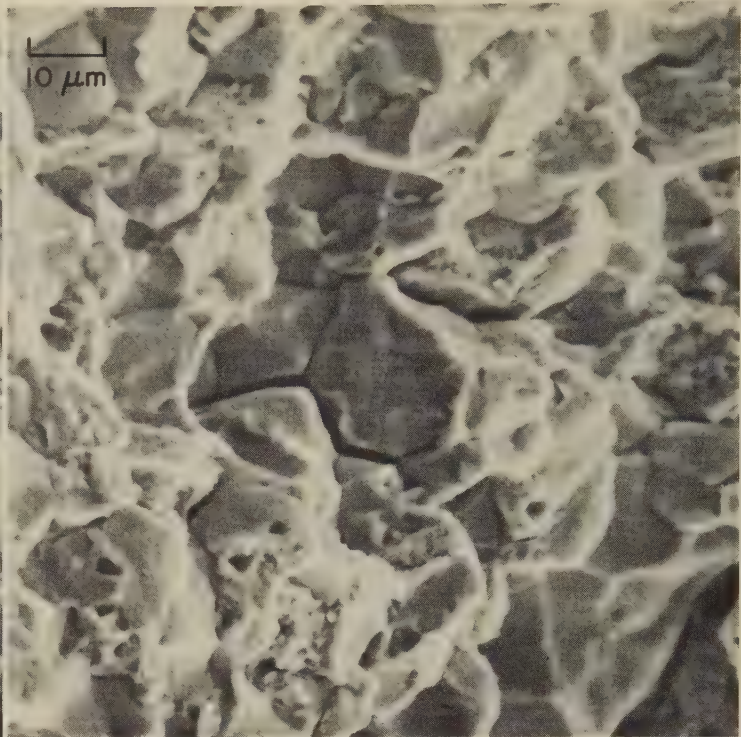
SEM fractograph 1000×
3731 Surface of a fracture in a specimen of 5155 steel that had been given exactly the same heat treatment as described for 3730 (at left), but that was broken by impact at room temperature. This higher fracture temperature produced a surface that is rated as 75% brittle and 25% ductile. Note the greater incidence of dimples. See also fractograph 3732.

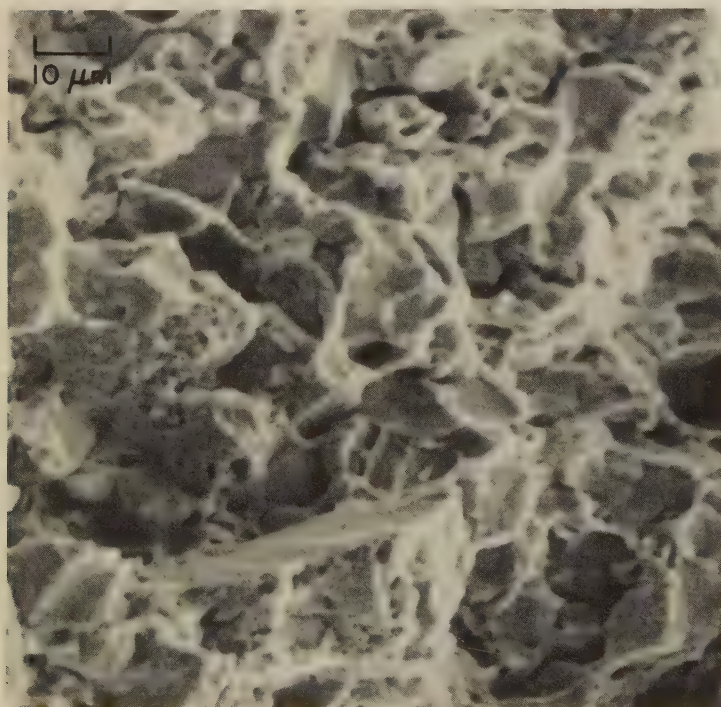
SEM fractograph 1000×
3732 Surface of a fracture in a specimen of 5155 steel that had been given exactly the same heat treatment as described for 3730 and 3731, but that was broken by impact at 100°C (212°F). The higher ductility of this fracture surface (rated 60% brittle, 40% ductile) compared with 3731 correlates with the greater number of fine dimples visible here.

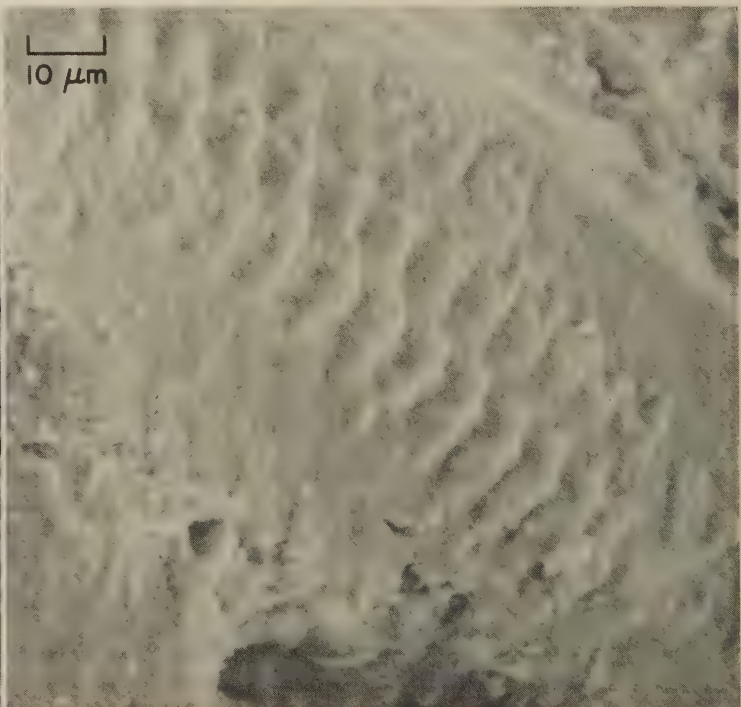
SEM fractograph 1000×
3733 Surface of a fatigue fracture in a specimen of 5155 steel that was broken in reversed torsion under a maximum stress of 1177 MPa (171 ksi). The specimen had been heat treated at 850°C (1562°F) for $\frac{1}{4}$ hr, oil quenched, and tempered at 450°C (842°F) for 1 hr. The hardness of the specimen was 425 dph. Fracture occurred at 2600 cycles. Note the fatigue "tire tracks".

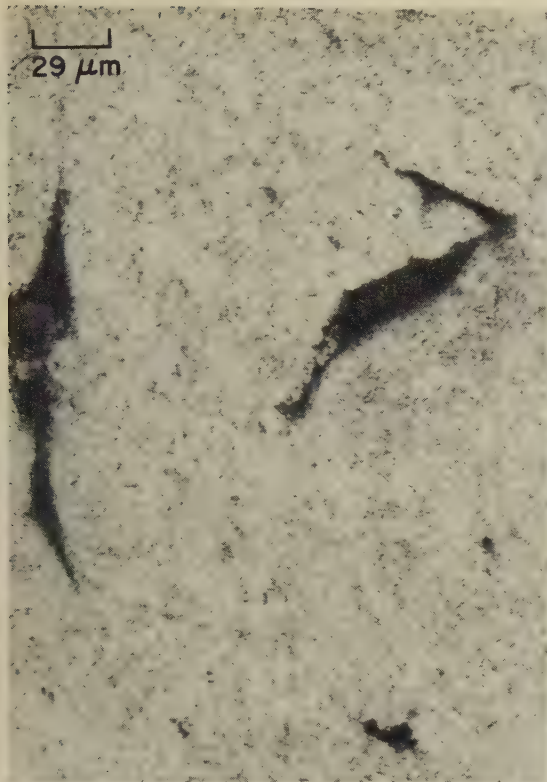
Micrograph - 3% nital

3734 Martensitic structure of a 50100 steel forging that was austenitized and water quenched. Because of inadequate flow in forging, grains are large and casting voids remain, both of which led to the fracture shown in 3735.

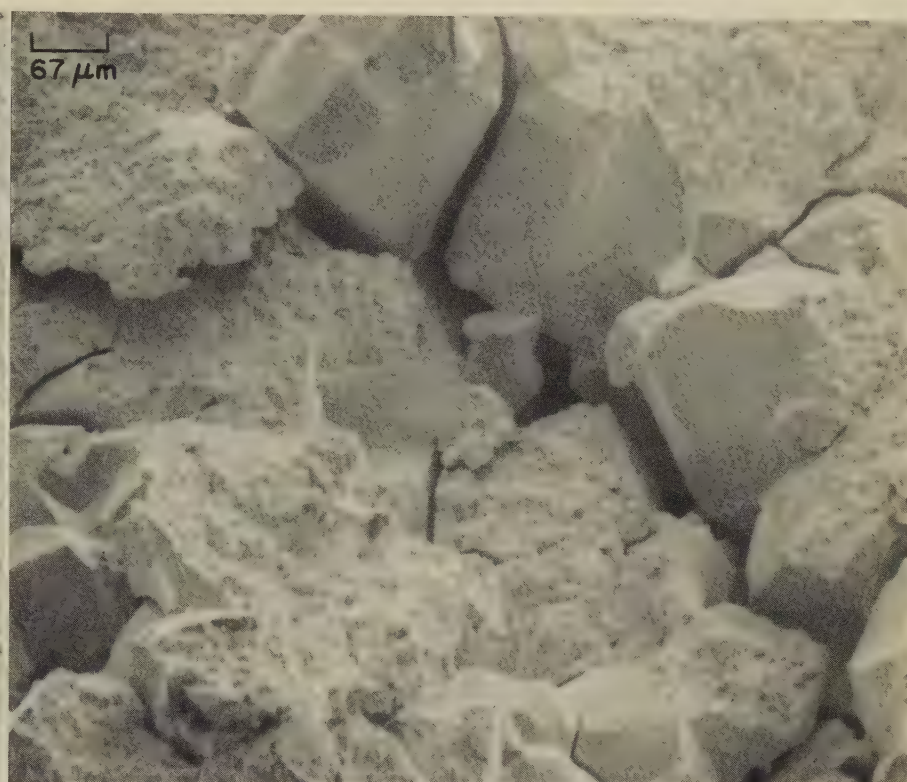
3735 Surface of a partly intergranular, partly transgranular quench crack in the 50100 steel forging shown in micrograph 3734 (at left). Both the large grain size and the presence of angular casting voids facilitated propagation of the intergranular portions of the fracture. At higher magnification, the transgranular portions of the fracture surface may exhibit dimples.

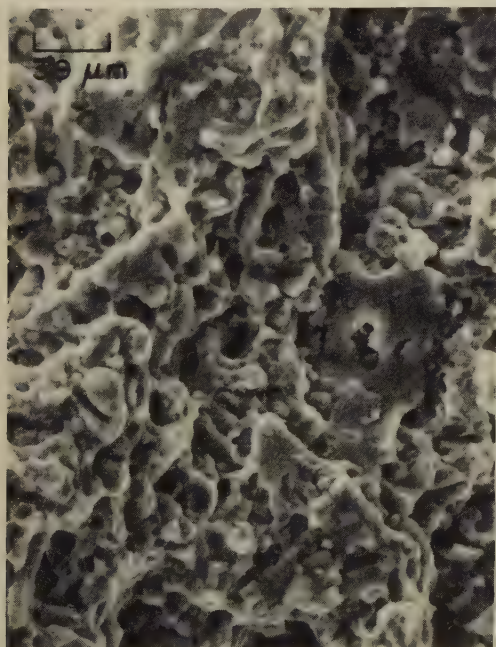
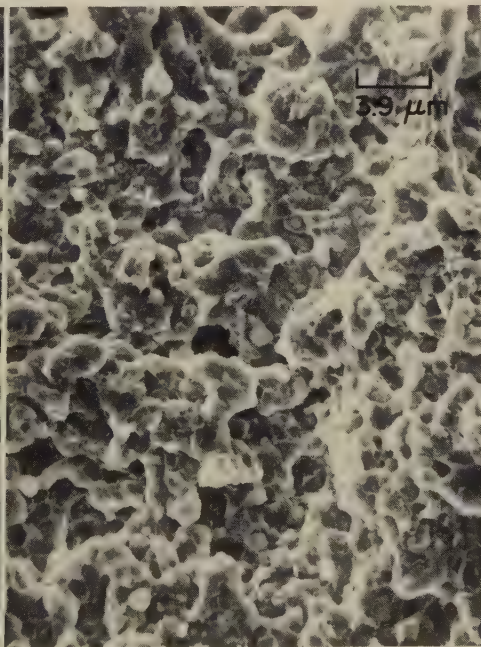
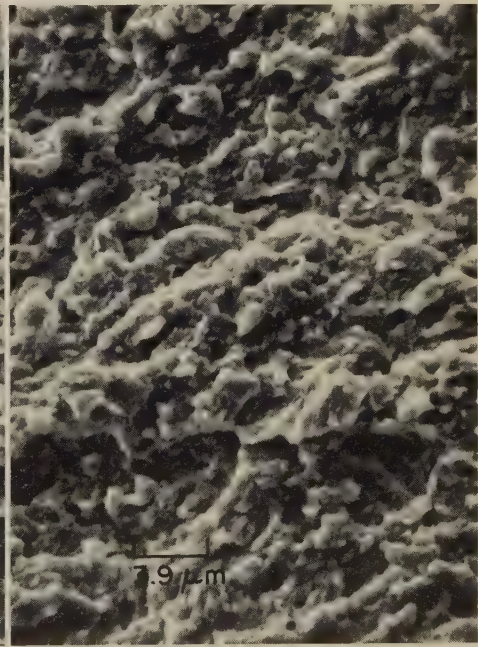
Fracture surface of three specimens of 52100 steel that were notched and broken by impact at -196°C (-321°F), presented to show the effect of rapid heating in austenitizing. The specimen in 3736 (left) had been heat treated at 845°C (1553°F) for 20 min and oil quenched (a conventional heat treatment), then tempered at 177°C (351°F). The specimen in 3737 (center) had been given two austenitizing cycles of rapid heating to 863°C (1585°F), holding for 1 min and oil quenching, and then had been tempered at 177°C (351°F). The specimen in 3738 (right) had been heat treated at 1095°C (2003°F) for 10 min and quenched in warm oil, tempered for 3 hr at 370°C (698°F), rapidly heated to 845°C (1553°F), held for 1 min and oil quenched, then tempered at 177°C (351°F). The successive decrease in size of cleavage facets and dimples from 3736 to 3737 to 3738 indicates successively decreasing size of acicular needles of martensite as a result of the different heat treatments.

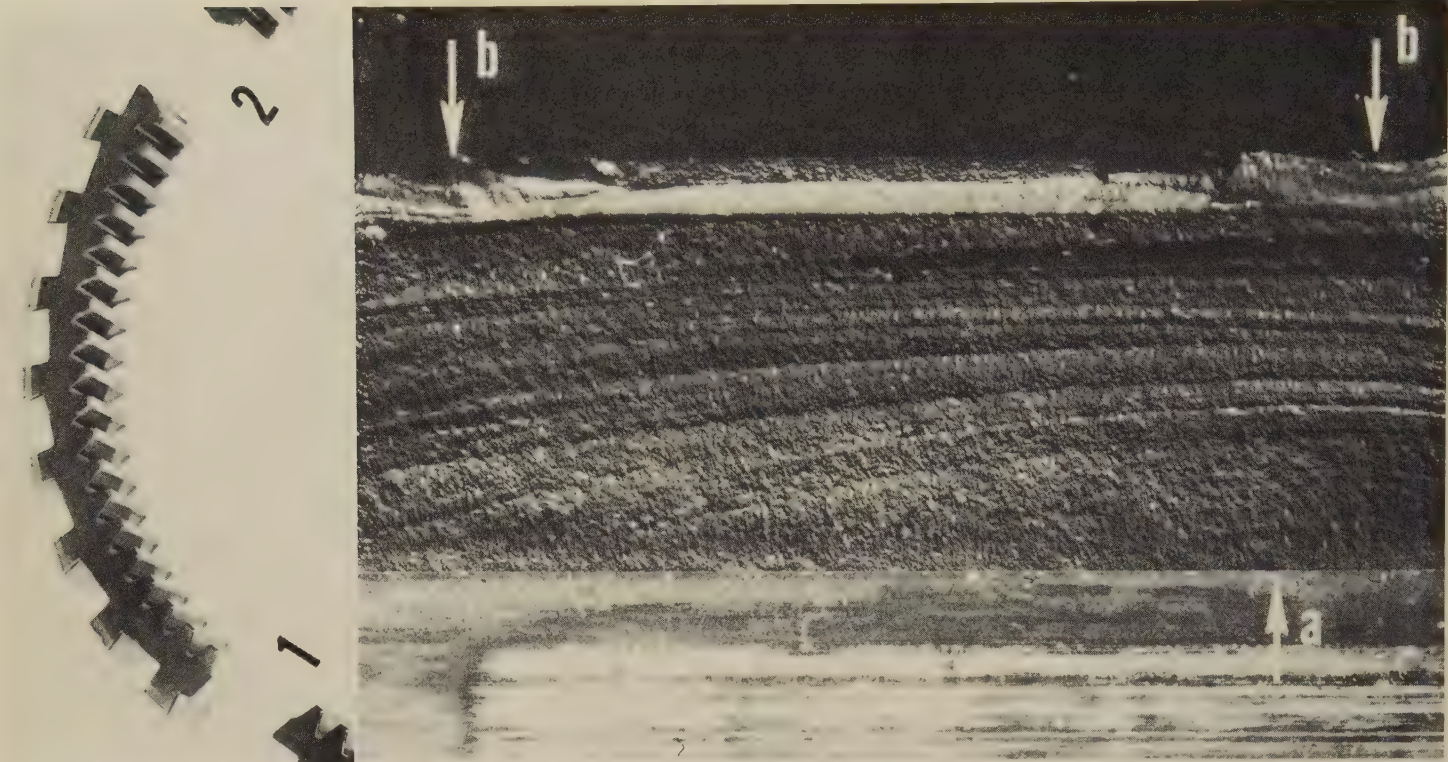
Photograph 0.6× Light fractograph 8×
3739, 3740 Fractured 7140 steel free-wheeling transmission gear that had been nitrided to a surface hardness of Rockwell 15N 91; core hardness was Rockwell C 36. The gear fractured by fatigue, breaking into three segments, one of which is shown in 3739 (left). All three fractures were similar. Fractograph 3740 (right) shows a surface of fracture No. 1. Arrow "a" points to the approximate location of the origin of the main fatigue crack, in the root of an inner tooth. This crack grew, making the clearly defined beach marks visible here, to meet two subordinate cracks (at arrows "b") that originated near a wear pattern between two outer teeth. In addition to the cracks that resulted in the fracture of the gear into three segments, similar cracks were observed in the roots of several inner teeth. One of these cracks is shown in macrograph 3741, and the surface of another is shown in fractograph 3742.

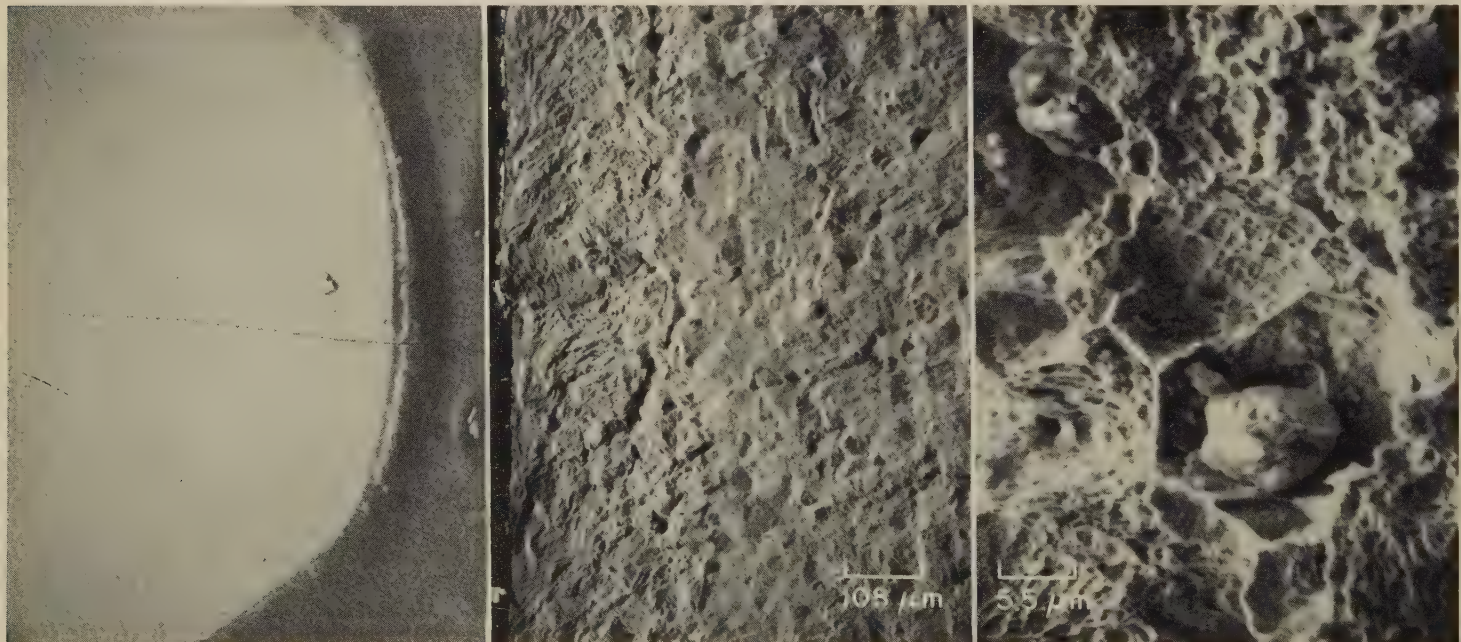
SEM macrograph 47×
3741 An oblique view of a fatigue crack in the root (light region at left) of an inner tooth of the gear segment in 3739. (The dark region at right is the side of the gear.) This crack is typical of several that were found in the roots of inner teeth. See also fractograph 3742.

SEM fractograph 93×
3742 Surface of a fatigue crack similar to that shown in 3741. This surface was exposed by application of a single overload in the laboratory. The left third of this fractograph shows the nitrided case. See fractograph 3743 (at right) for a view of the overload portion of this fracture.

SEM fractograph 1825×
3743 Overload fracture produced to expose the fatigue crack in 3742, showing the dimples expected in this type of fracture. The large inclusions visible here were nowhere found to be associated with crack origins, which appeared to be related to tool marks.

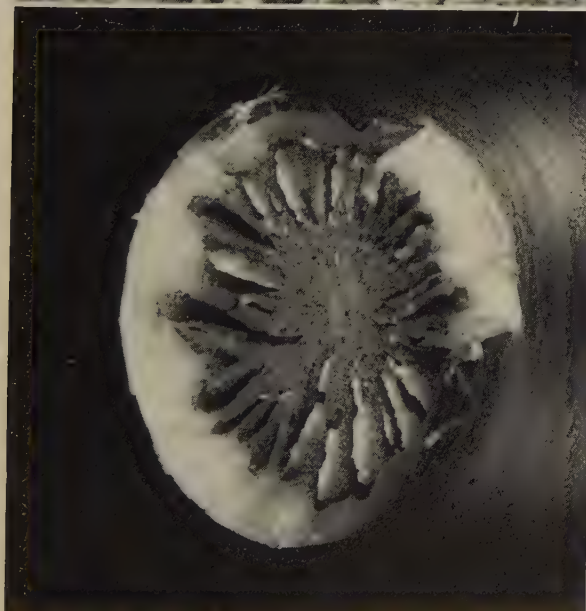
Light fractograph
3744 Tensile-overload fracture in an unnotched specimen of 8740 steel; tensile strength 1351 MPa (196 ksi). A cup-and-cone fracture with a fibrous zone containing radial features between the central fibrous region and the shear lip. See 3745-3746.

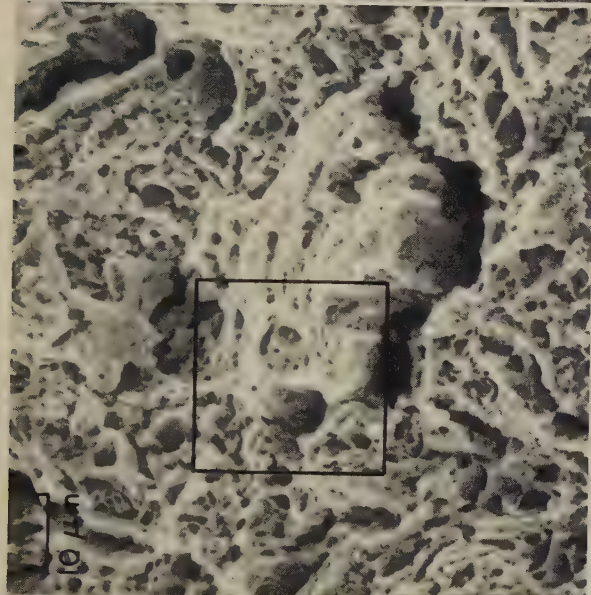
SEM fractograph 1000×
3745 Area adjacent to one of the radial features in 3744, showing dimples, which are typical of tensile-overload fracture. Note the scattered secondary cracks, which appear to be unusually deep. See 3746, a higher-magnification view of area in the rectangle.

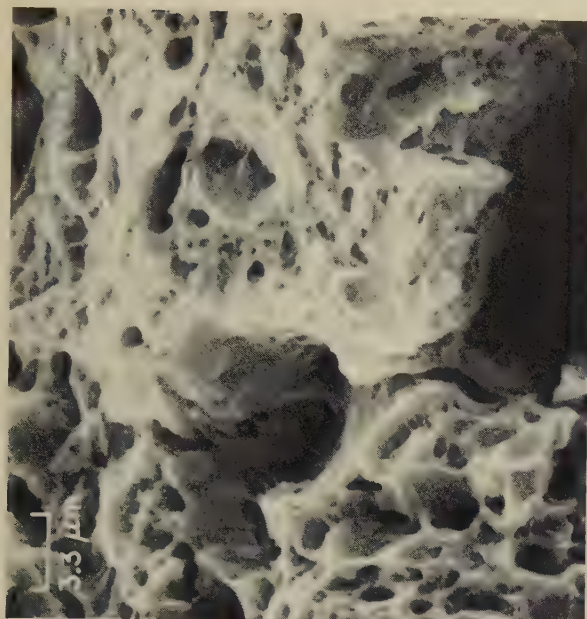
SEM fractograph 3000×
3746 Area outlined by the rectangle in fractograph 3745 (at left), shown at higher magnification. A wide range of sizes of the dimples is clearly visible. Unlike many other dimpled fractures, the one here appears to contain no evidence of inclusions.

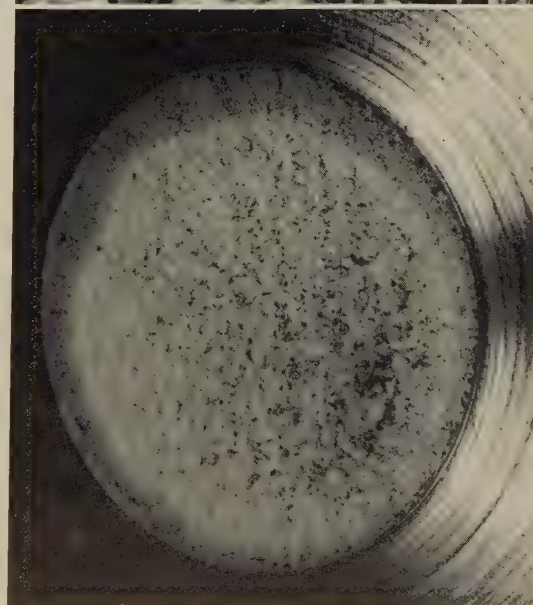
Light fractograph 9×
3747 Surface of tensile-overload fracture in a notched specimen of 8740 steel heat treated to a tensile strength of 2044 MPa (296.5 ksi). Fracture originated around the periphery of the specimen at the root of the notch. Radial features are evident. See also 3748 to 3751 (at right, and on the next page).

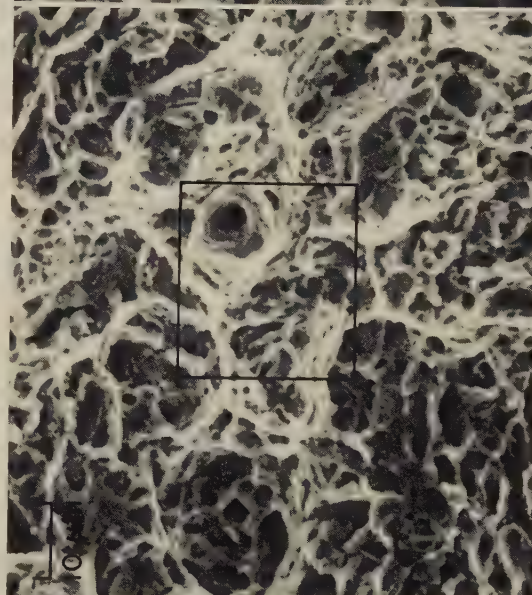
SEM fractograph 1000×
3748 Area in the central final-fracture region in 3747. The range of dimple sizes is similar to that in the unnotched fracture in 3745, but only one secondary crack is evident, and it is of modest size. See fractograph 3749, at right, for a higher-magnification view of the area outlined by the rectangle.

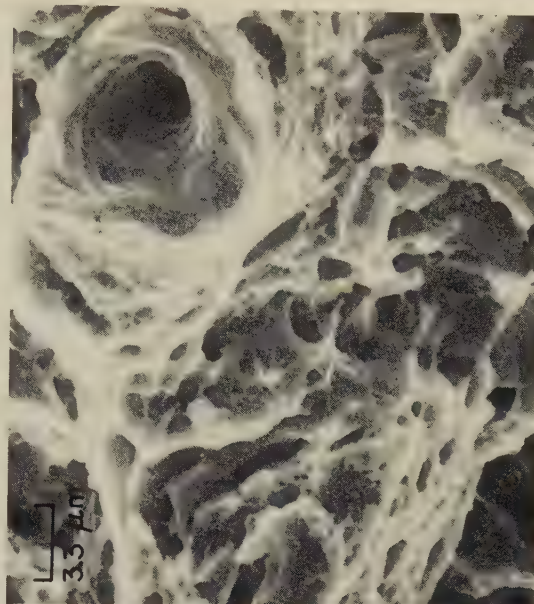
SEM fractograph 3000×
3749 Higher-magnification view of the area in the rectangle in 3748 (left). Range in dimple size is more clearly evident here. Large dimple at upper right was presumably initiated by a large inclusion (not shown). See 3750 and 3751 (next page) for views of the crack-nucleus area at the rim.

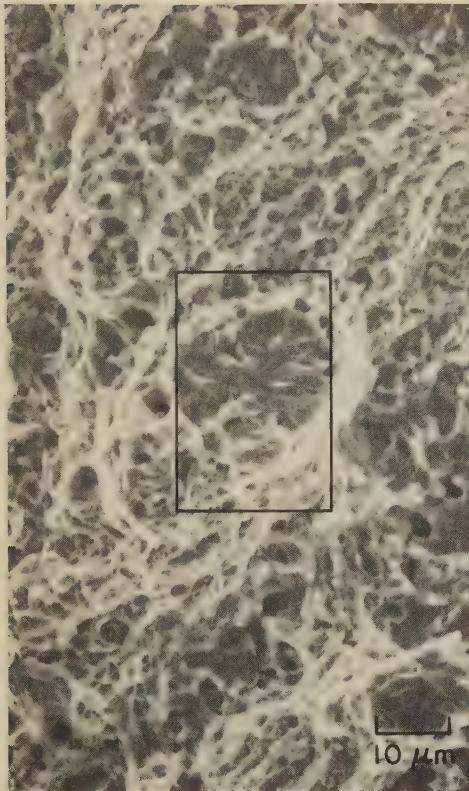
SEM fractograph 1000×
3750 Same fracture surface (8740 steel) as in 3747, showing crack-nucleus area at rim. Compare the radial features in the circular area at center with those in 3744. See 3751 for a higher-magnification view of the area in the rectangle.

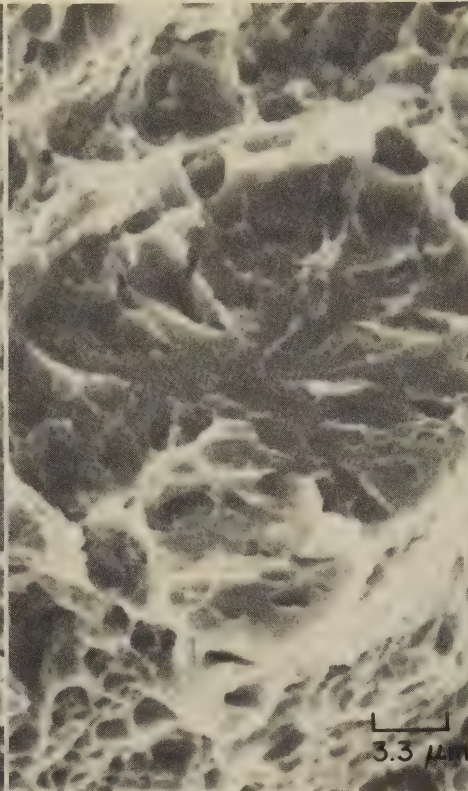
SEM fractograph 3000×
3751 A higher-magnification view of the area within the rectangle in fractograph 3750 (at left). The radial pattern visible here bears a superficial resemblance to that shown in 3744, but is the result of local quasicleavage.

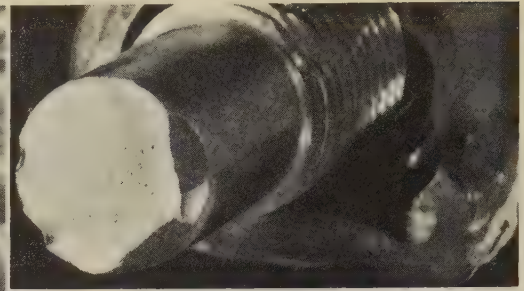
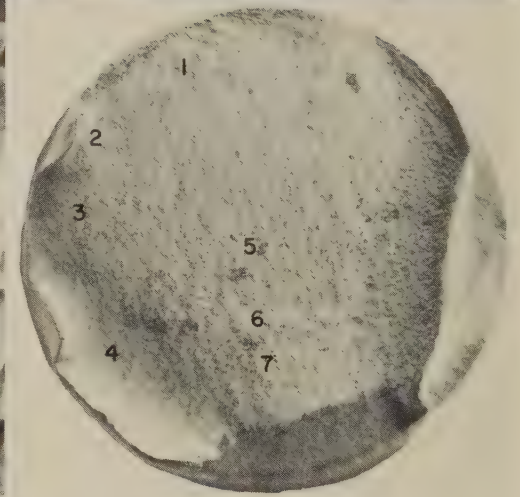
Light fractographs 3 1/3 × (3752); 8 × (3753)
3752 Perspective view (3752) and end-on view (3753) of the surface of a fatigue fracture in an aircraft bolt of 8740 steel. Hardness, Rockwell C 40; tensile strength, 1241 MPa (180 ksi). Numbers in 3753 refer to locations of 3754 to 3762.

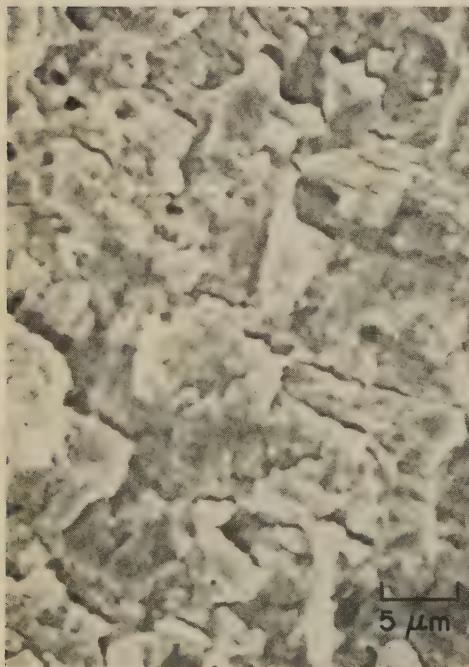
SEM fractograph 2000×
3754 View at position No. 1 in 3753, near the origin of the fatigue fracture. Fragmentary fatigue striations are visible, many of which are associated with fissures.

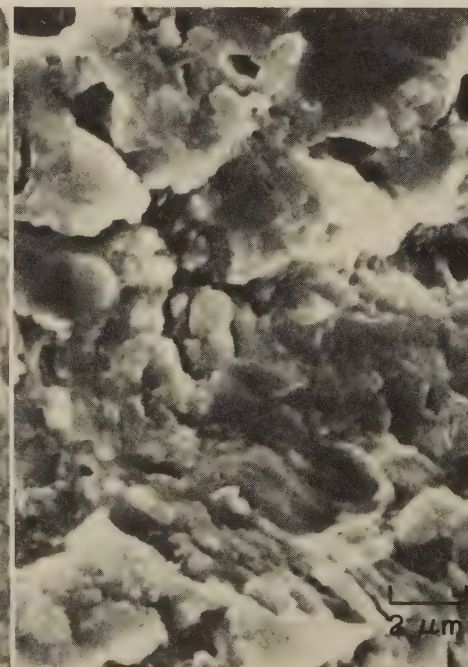
SEM fractograph 5000×
3755 Another view at position No. 1 in 3753, at higher magnification than fractograph 3754 (left), showing scattered voids that have very irregular shapes.

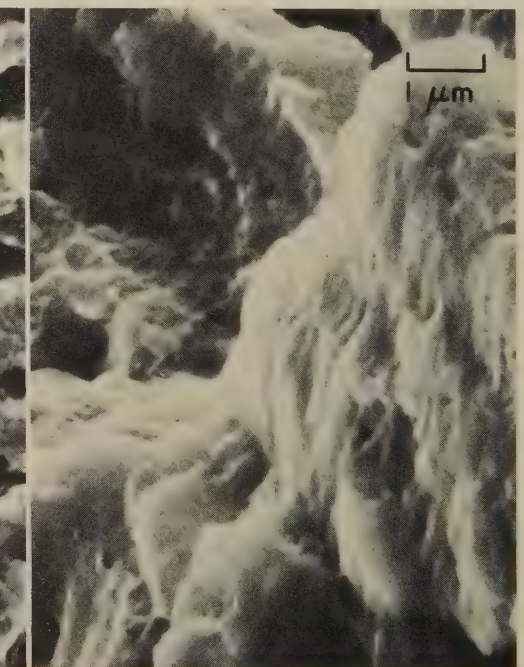
SEM fractograph 10,000×
3756 View at position No. 2 in 3753, farther from the origin than 3754 and 3755 and near (but not affected by) the damage at the surface. A few tiny dimples.

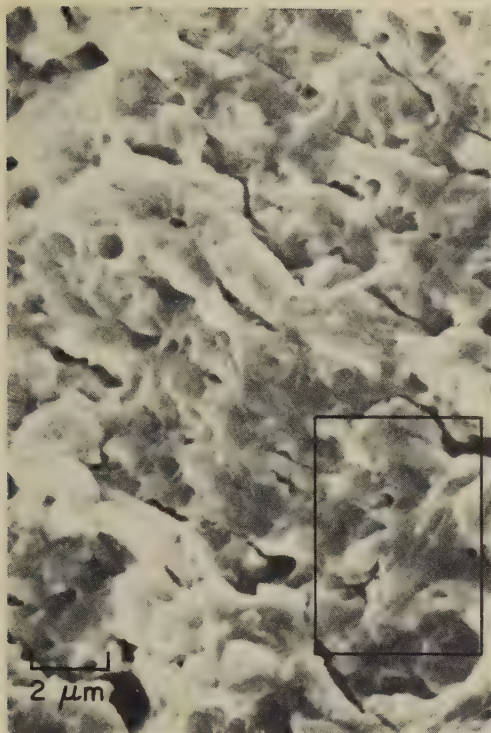
SEM fractograph 5000×
3757 View at position No. 3 in 3753, showing fissures (or striations) that were found to be perpendicular to the marks in 3753 radiating from the crack origin near position No. 1. See 3758.

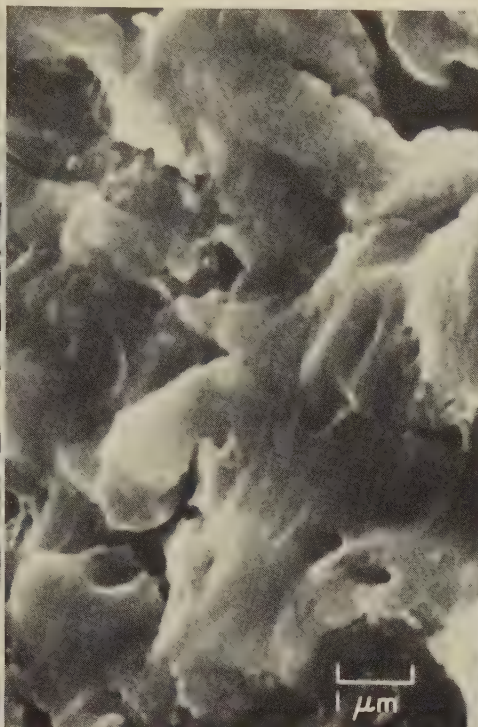
SEM fractograph 10,000×
3758 Higher-magnification view of the area within the rectangle in fractograph 3757 (at left). Note that the facets exhibit striation-like features that are perpendicular to the array of fissures.

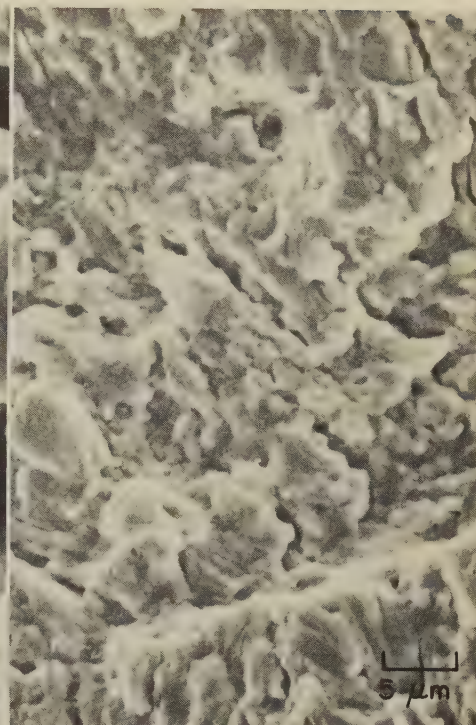
SEM fractograph 2000×
3759 View at position No. 4 in 3753. The system of fissures shown in 3757 and 3758 is visible here as well. Although this region is near the shear lip, no evidence of fast fracture can be seen.

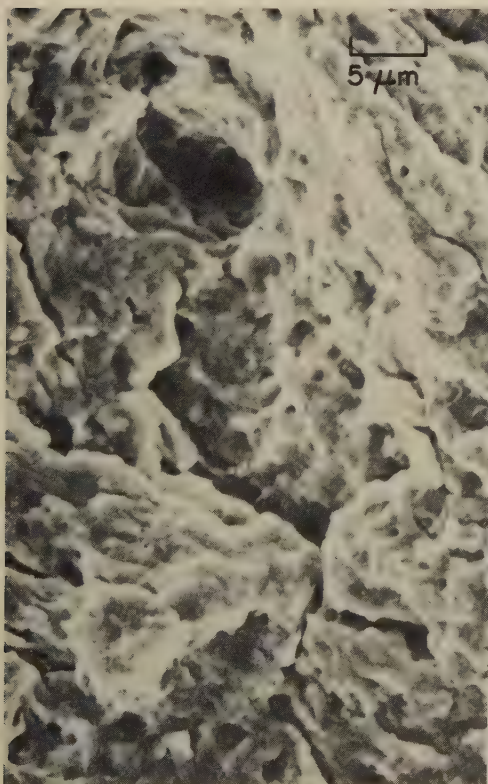
SEM fractograph 2000×
3760 View at position No. 5 in 3753 (near center), showing the end of the fatigue portion of the fracture, and the dimples characteristic of fast fracture.

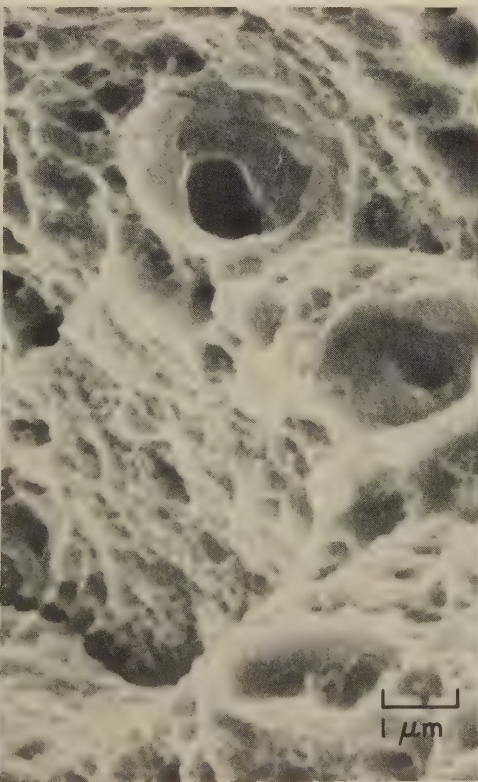
SEM fractograph 10,000×
3761 View at position No. 6 in 3753. No evidence of fatigue. Here, fracture occurred entirely by microvoid coalescence. Note the small, well-defined voids.

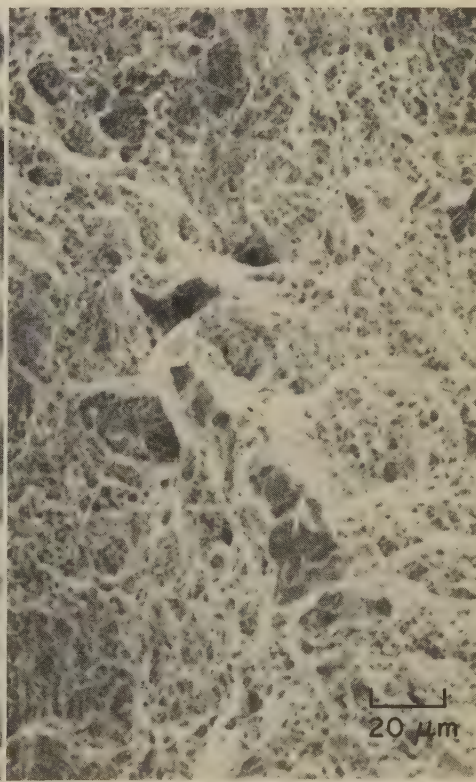
SEM fractograph 500×
3762 View at position No. 7 in 3753. This region was produced near the final moment of fracture, but not close enough to the shear lip to show shear dimples.

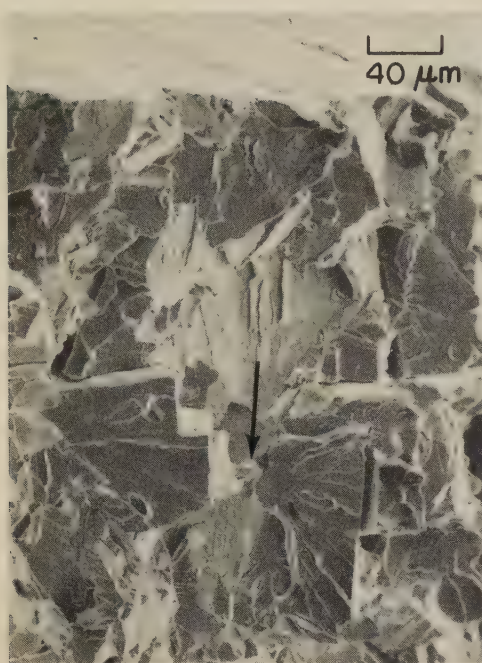
SEM fractograph 250×
3763 Surface of a slow-bending fracture produced at -160 C (-256 F) in Fe-3.9Ni alloy deoxidized with aluminum and titanium, which was forged at 1260 C (2300 F), hot rolled at 1040 C (1904 F), annealed at about 1000 C (1832 F), air cooled. Root of specimen notch is at top. Fracture was by cleavage that began at cracked Ti(C,N) particles (as at arrow). See 3764.

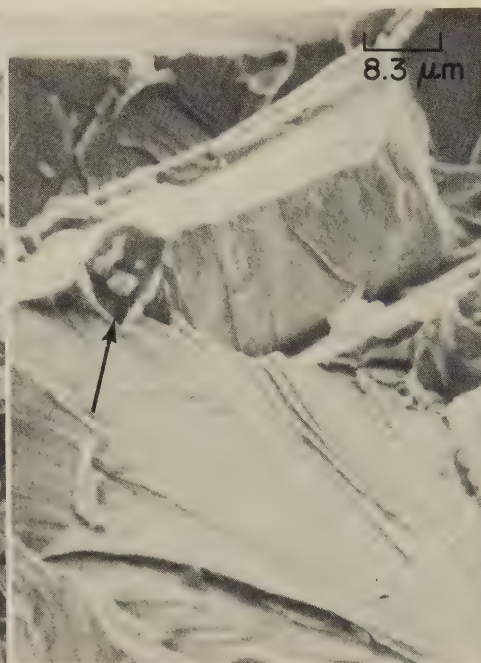
SEM fractograph 1200×
3764 Higher-magnification view of the slow-bending fracture in 3763 (at left). During testing, specimen temperature was controlled by an isopentane bath cooled with liquid nitrogen. Ferrite grain size, 30 μm . The angle of the notch was 45° , and the nominal radius of the root of the notch was 0.01 in . The fracture originated at cracked Ti(C,N) particles (as at arrow).

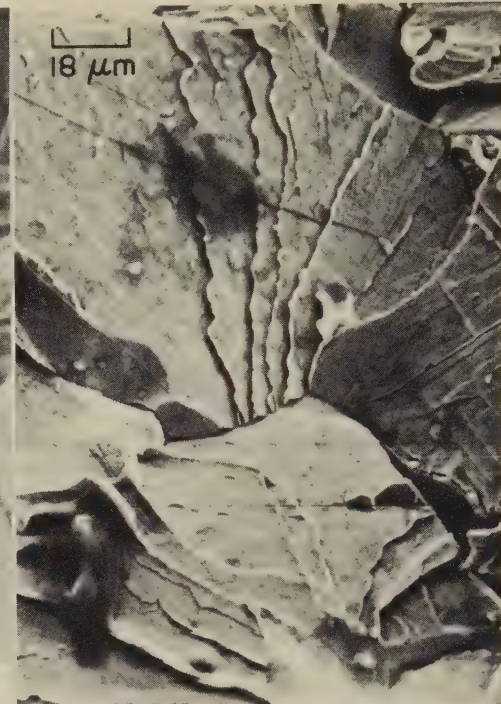
SEM fractograph 550×
3765 Surface of a slow-bending fracture that was produced at -130 C (-202 F) in an Fe-0.3Ni alloy that had been melted, deoxidized, forged, rolled and heat treated exactly the same as the higher-nickel alloy shown in fractographs 3763 and 3764. See also fractographs 3766 to 3768 (below).

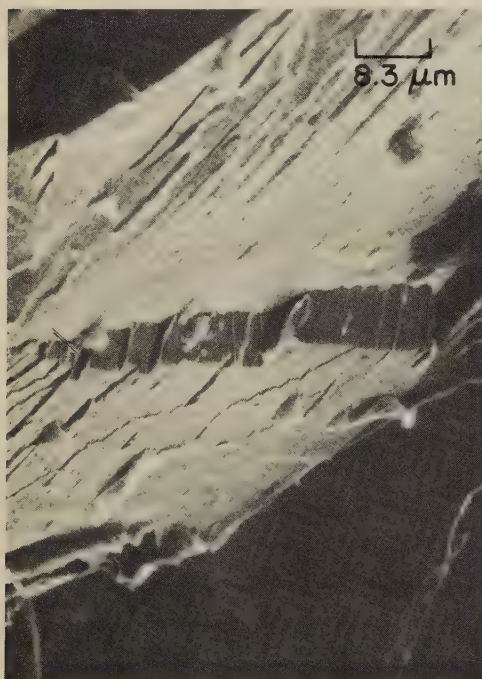
SEM fractograph 1200×
3766 Another view of the slow-bending fracture in 3765, showing a different region of the fracture surface at higher magnification. Here, as in the specimen shown in 3763 and 3764, fracture was by quasicleavage. Also shown is the intersection of a twin boundary with the cleavage plane. See also fractograph 3767 (right).

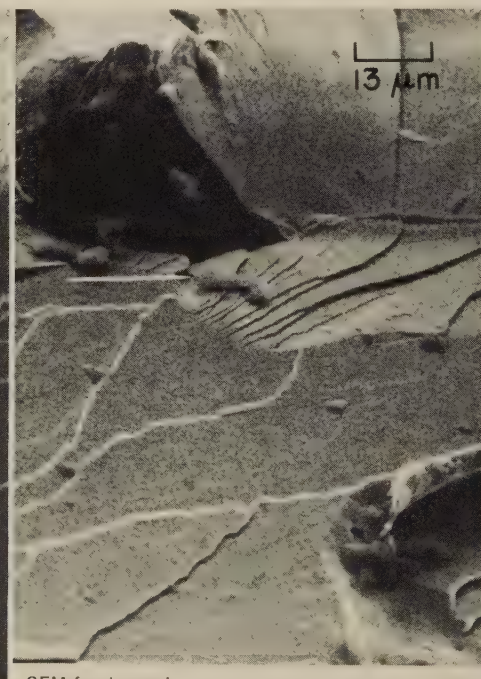
SEM fractograph 750×
3767 Surface of a bending fracture in a specimen of the same alloy and the same history as that in 3765, showing assorted river patterns. Note twist boundary at center, which has generated several cleavage steps. Although the higher nickel content of the alloy in 3763 gave greater strength, the aspects of subzero impact rupture are about the same for both alloys. See 3768.

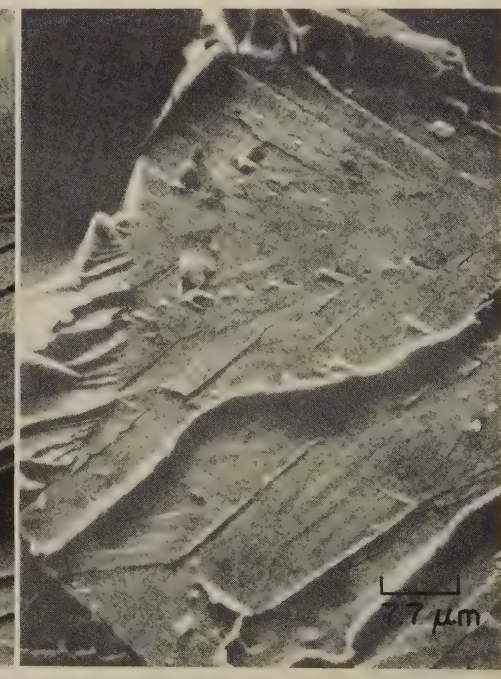
SEM fractograph 1300×
3768 Another view of the bending fracture in 3767, showing a different region at higher magnification. This region best demonstrates the difference between this Fe-0.3Ni alloy and the Fe-3.9Ni alloy in 3763 and 3764 by displaying many small "tongues", or microtwins, which are characteristic of Fe-0.3Ni, and also of unalloyed (Armco) iron, but not of Fe-3.9Ni.

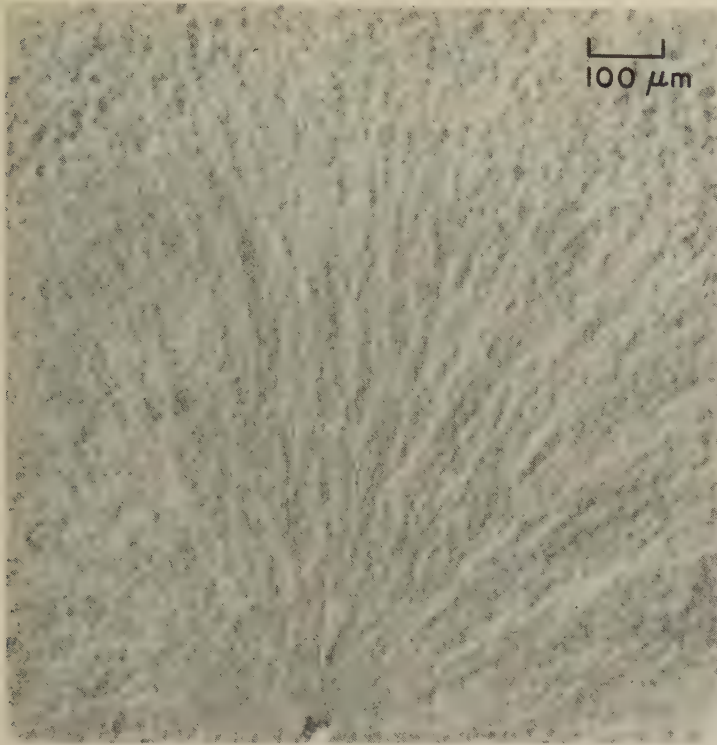
3769 Surface of a fatigue fracture produced in rotary bending in a specimen of 0.20% C, 1.0% Mn, 3.05% Ni, 1.65% Cr, 0.5% Mo steel carburized 5 hr at 925 C (1697 F), heat treated ½ hr at 870 C (1598 F), oil quenched, heat treated ½ hr at 832 C (1530 F), oil quenched, and tempered 1 hr at 150 C (302 F). The crack origin (at bottom) is at an alumina inclusion.

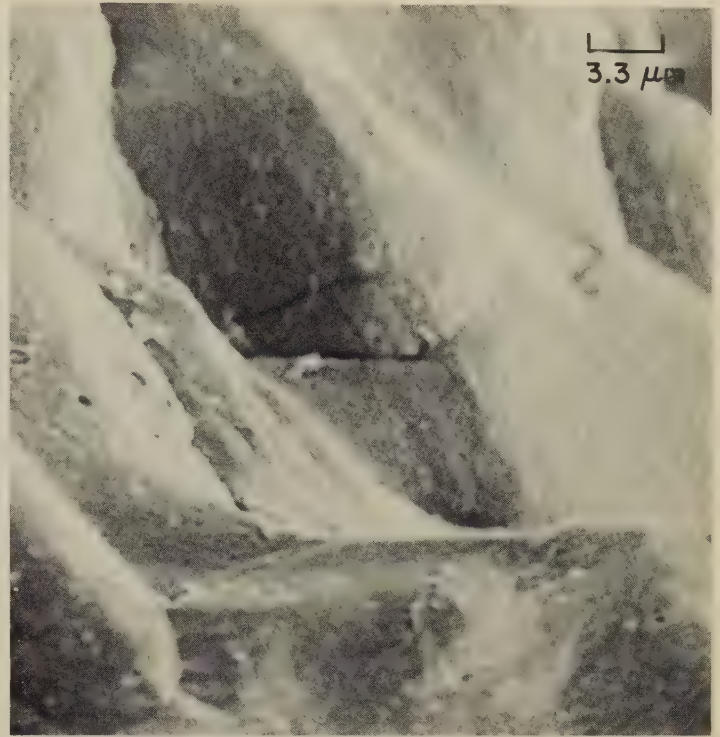
3770 Surface of a Charpy impact fracture in a specimen of 3.5% Ni, 1.5% Cr, 0.5% Mo, 0.1% V steel that had been tempered to a hardness of 260 Bhn. This "rock-candy" intergranular fracture was produced by impact testing at 20 C (68 F) after the specimen had been given an embrittling treatment of 100 hr at 500 C (932 F). See also fractographs 3771 and 3772, below.
